COMET LAKE DAM

(NDI ID. No. PA-00796, Number  
PENNDER ID. No. 28-103) Number

PHASE I INSPECTION REPORT,  
NATIONAL DAM INSPECTION PROGRAM

(11) AUG 1980

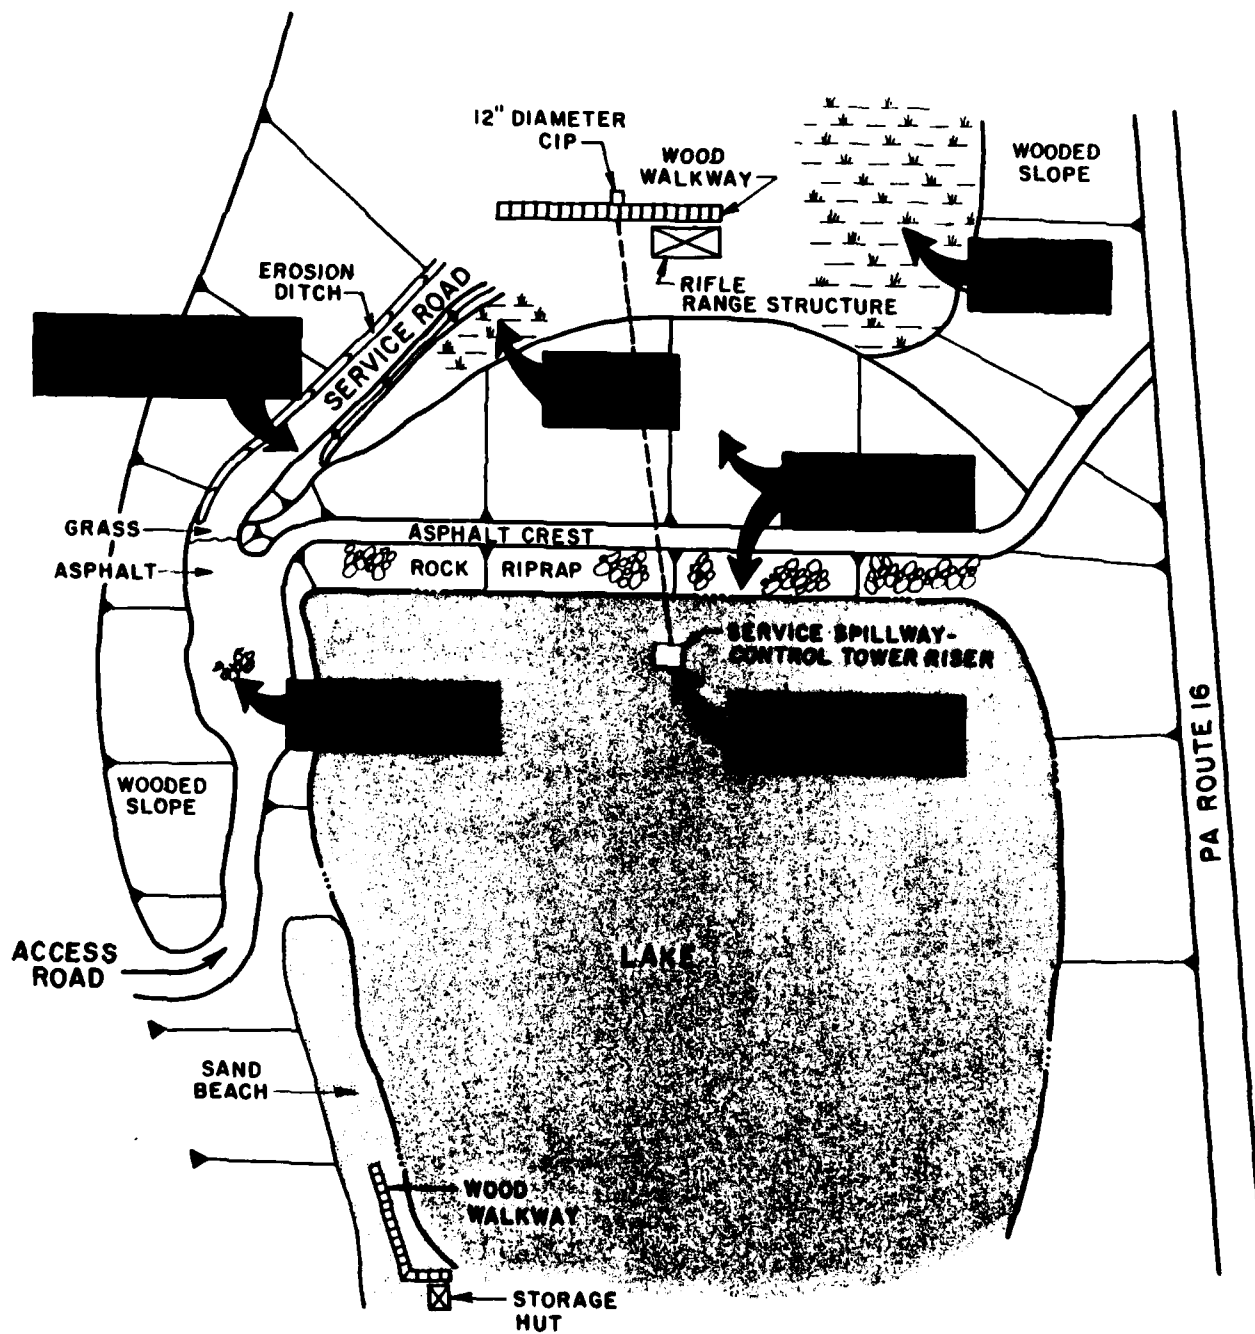
COMET LAKE DAM  
GENERAL PLAN - FIELD INSPECTION NOTES

ITEM	OBSERVATIONS/REMARKS/RECOMMENDATIONS	ND# PA. 00796
DAMP AREAS IRREGULAR VEGETA- TION (LUSH OR DEAD PLANTS)	Two areas (see "General Plan-Field Inspection Notes," Appendix A). 1. Area several feet to the right of the emergency spillway. 2. Area immediately downstream of toe along right abutment ( $\approx$ 30 feet wide).	
ANY NOTICEABLE SEEPAGE	None through face of dam; however, both areas listed above are saturated and exhibit noticeable seepage.	
STAFF GAGE AND RECORDER	None.	
DRAINS	None observed.
